ACTION MEMORANDUM

SUBJECT: Request for a Ceiling Increase and Change of Scope for a Time-Critical Removal Action at the Smokey Mountain Smelters Site, Knoxville, Knox County, Tennessee

ATTACHMENT B
PHOTO LOG

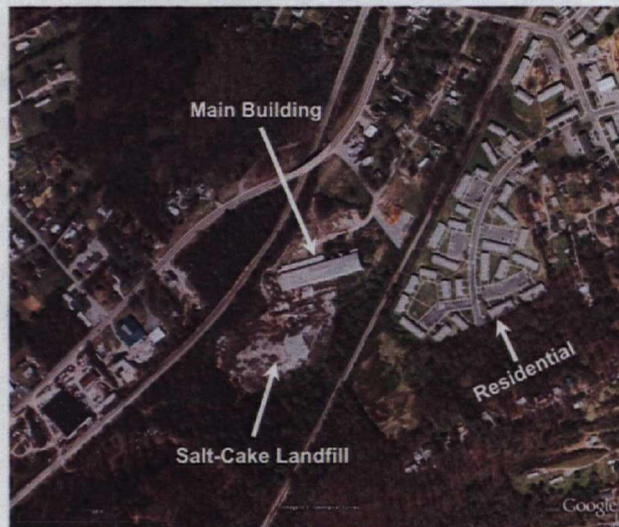
Figure No. 1 – Aerial of Site and Surrounding Features.

stronger security measures in order to keep trespassers away from the water-reactive dross material and collect additional data to determine if further waste removal or treatment action is necessary (Figure 1).

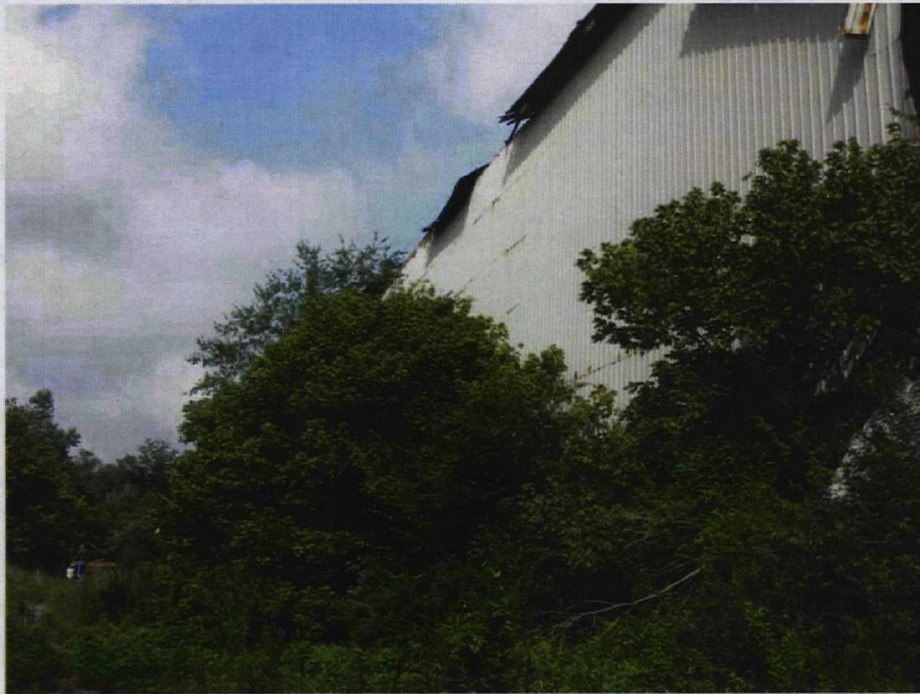
August, 2008

View of south wall of main process building. TDEC representative can be seen in bottom left corner of photo.

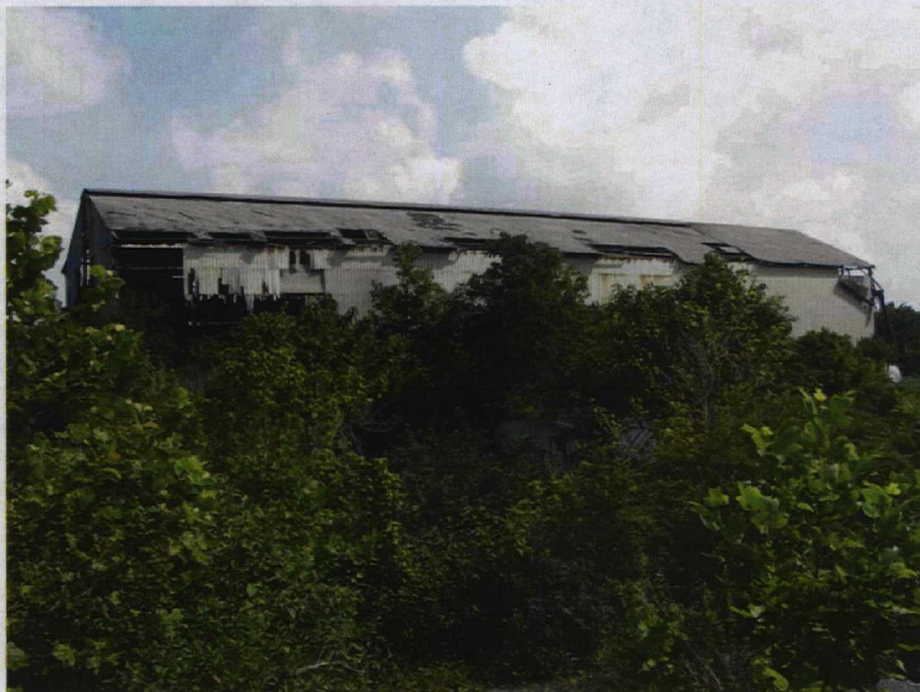
August, 2008

View of south wall of main process building from high mound of waste pile. 1/3 of Eastern portion of process building has collapsed. SW corner wall is missing.

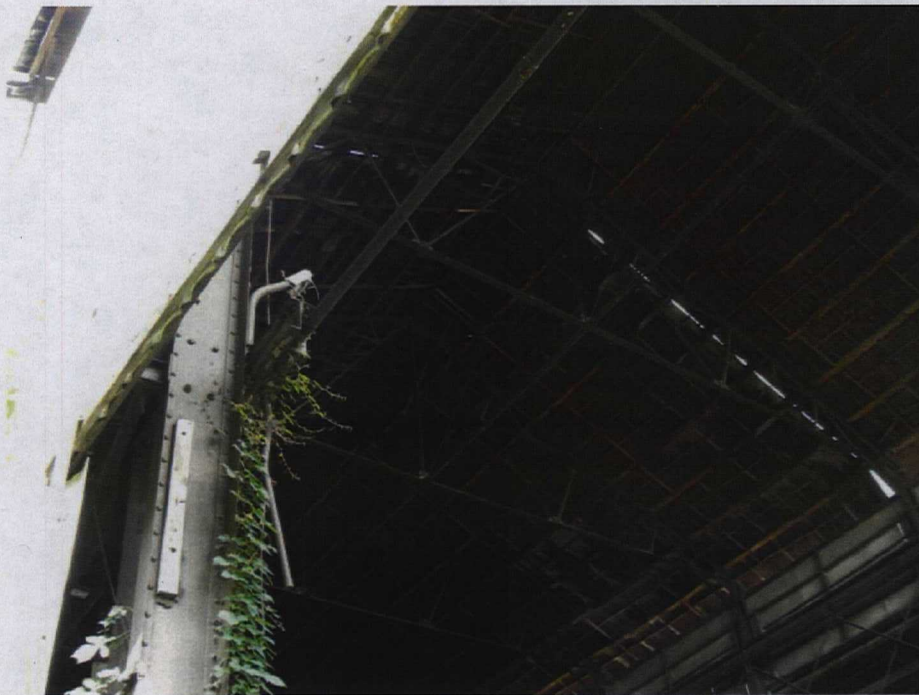
August, 2008

View of ceiling of main process building. Steel beam support with steel trusses and wooden roof. Roof is failing and wood falls periodically.

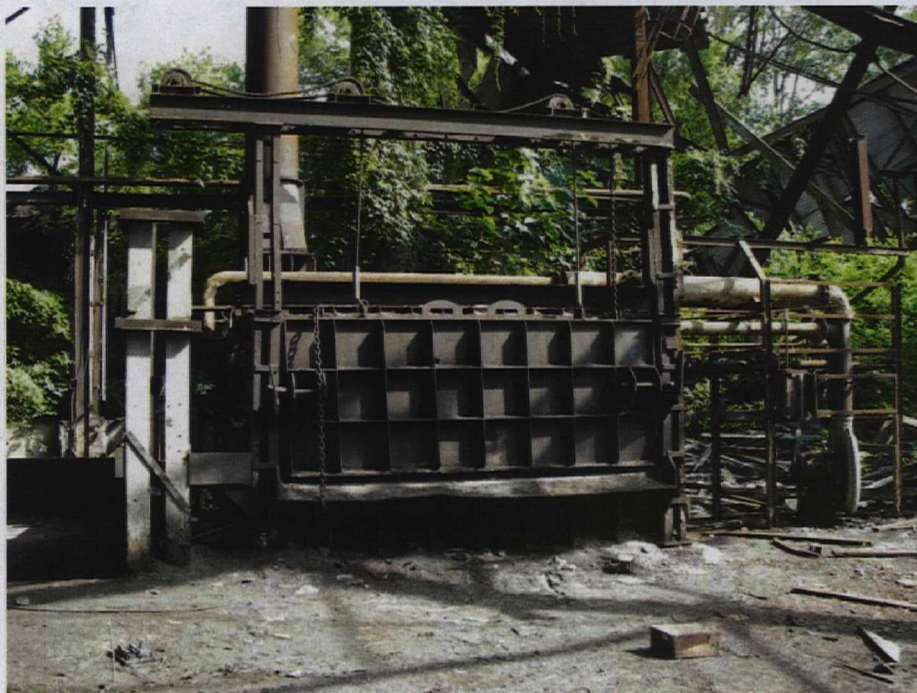
August, 2008

Unidentified machine/equipment in process building.

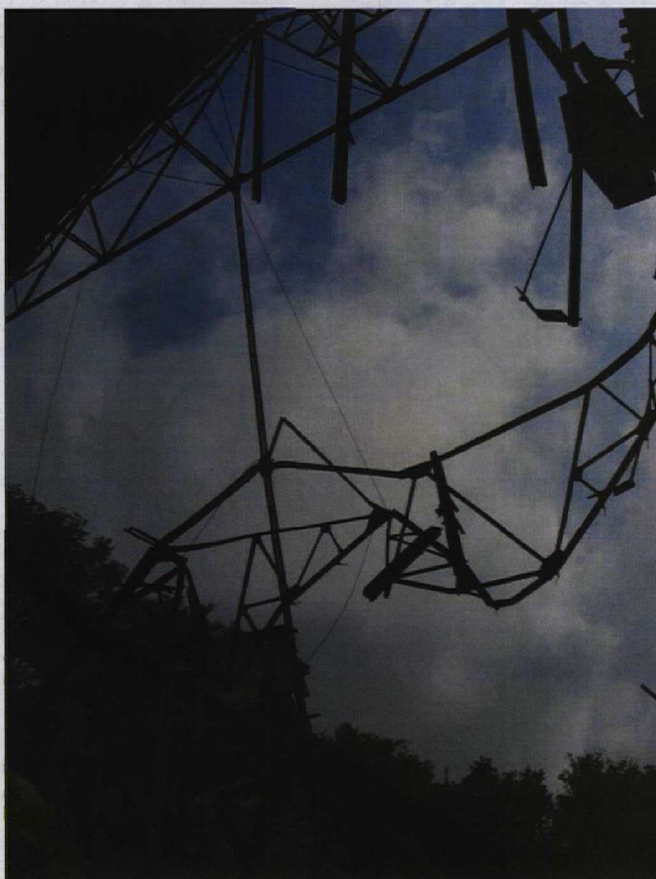
August, 2008

View of truss at point where collapsed portion of process building meets the still-standing portion. Truss shown is suspended 20-30' in air

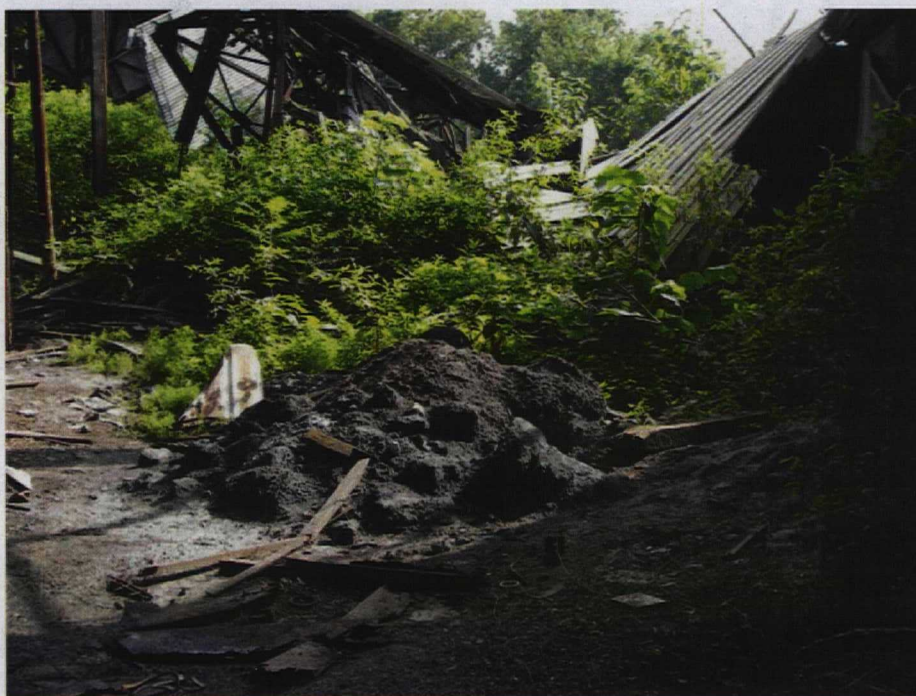
August, 2008

Small dross/saltcake pile in process building.

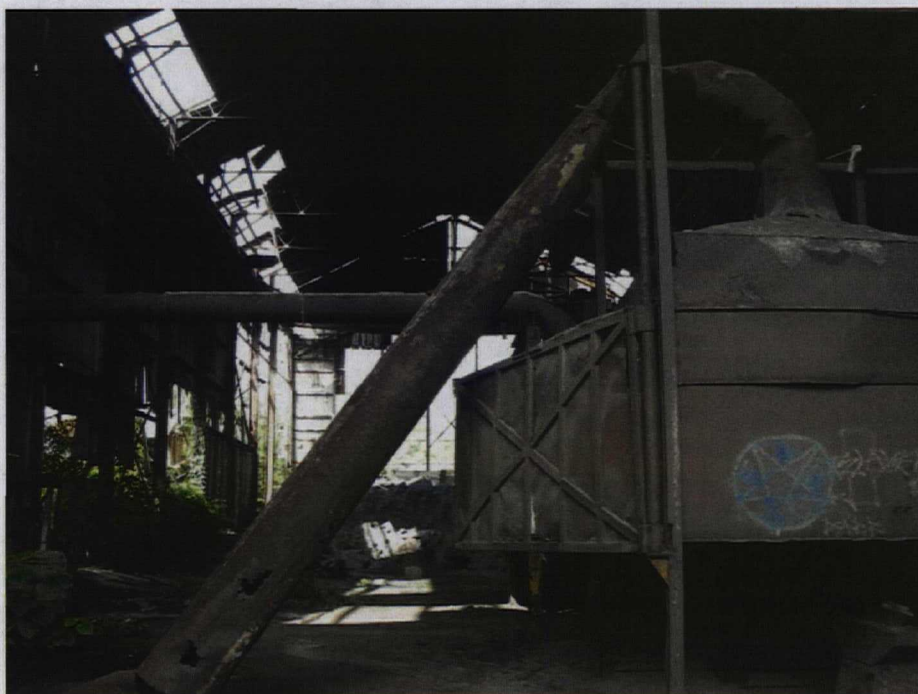
August, 2008

Air ducts from rotary furnace to baghouses. Graffiti shows that the process building is regularly visited by trespassers.

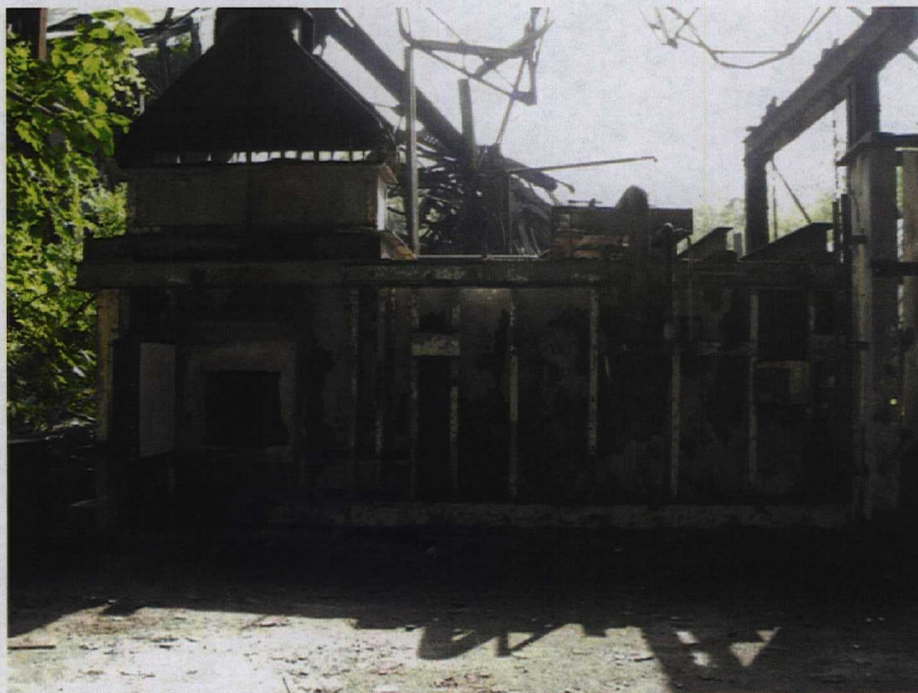
August, 2008

Furnace in process building; door remains open, with aluminum dusts and fly ash inside.

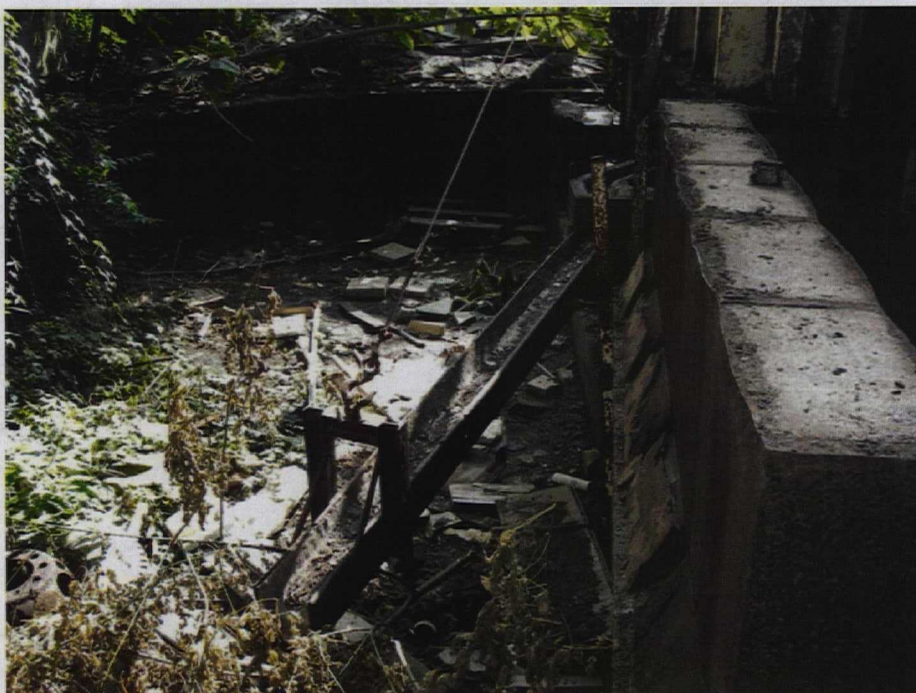
August, 2008
Molten aluminum slide emitting from furnace for casting ingots.

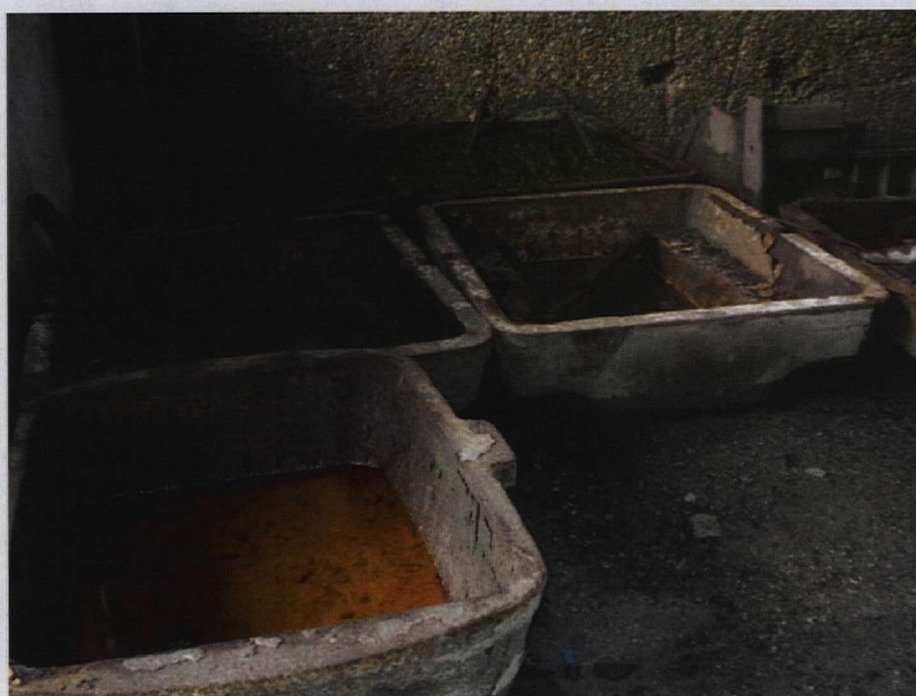
August, 2008
Saltcake troughs in process building.

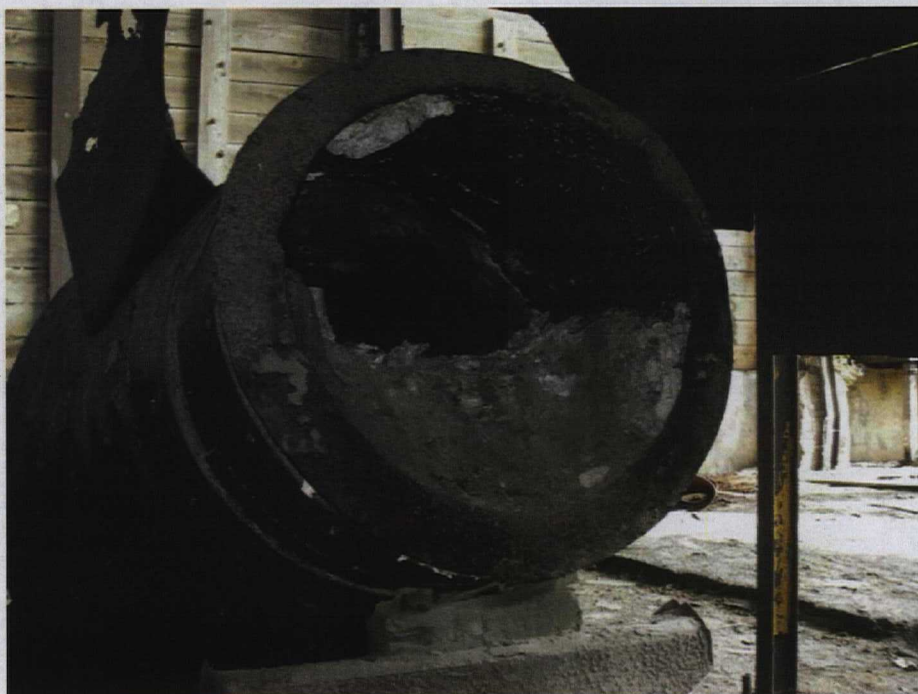
August, 2008
Rotary kiln furnace in process building, filled with dross residue.

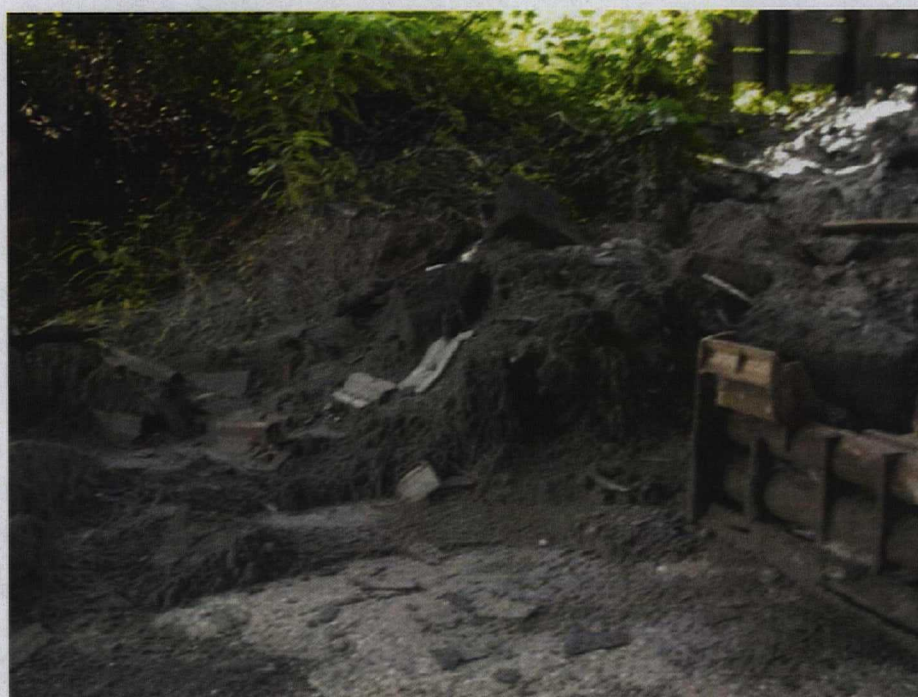
August, 2008
Small saltcake pile in process building.

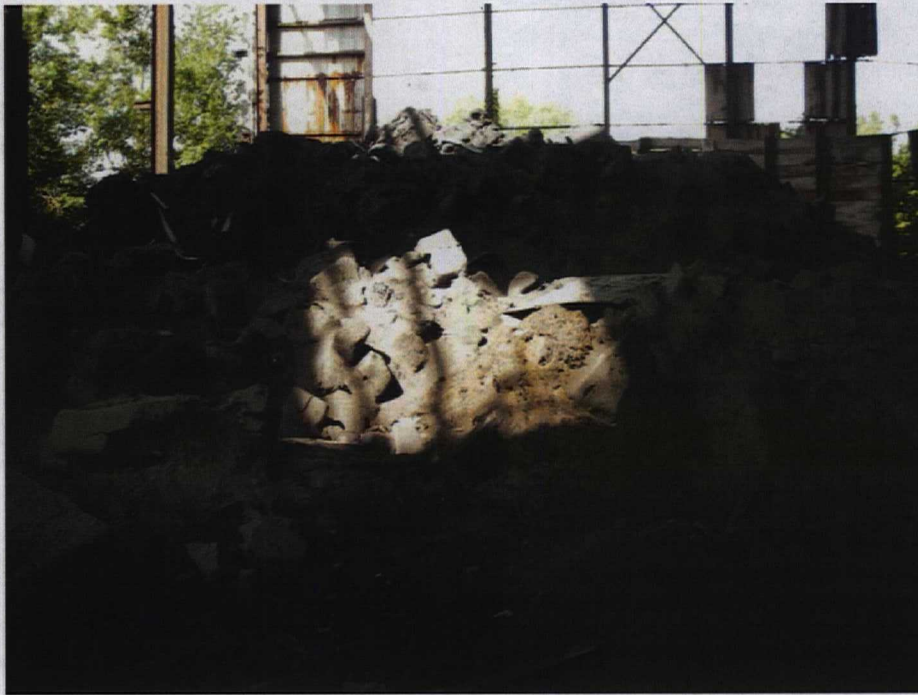
August, 2008

Large dross pile in southwest corner of process building; approximately 900 cubic yards total volume.

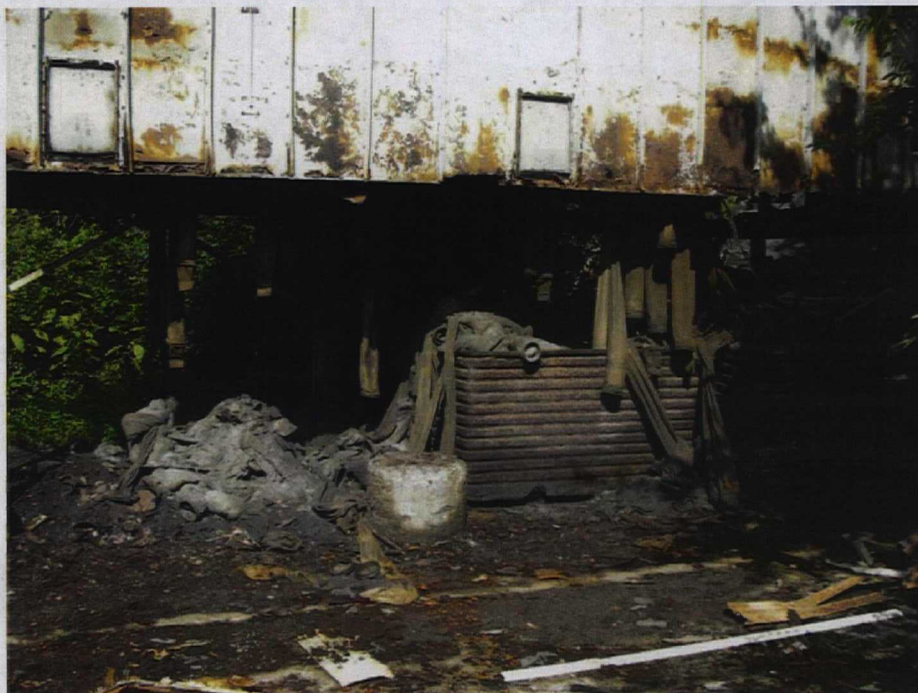
August, 2008

Bottom of western baghouse, with used socks and large bins filled with baghouse dusts.

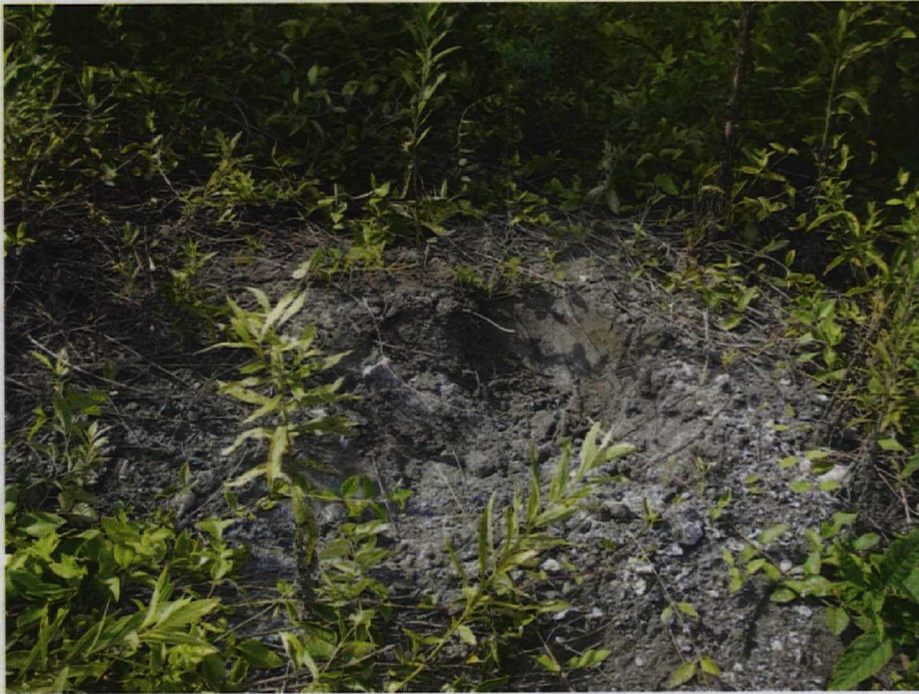
August, 2008

Excavation of saltcake in waste pile at western edge. Vegetation is growing on organic matter that is decomposing on the waste pile, no roots enter the saltcake.

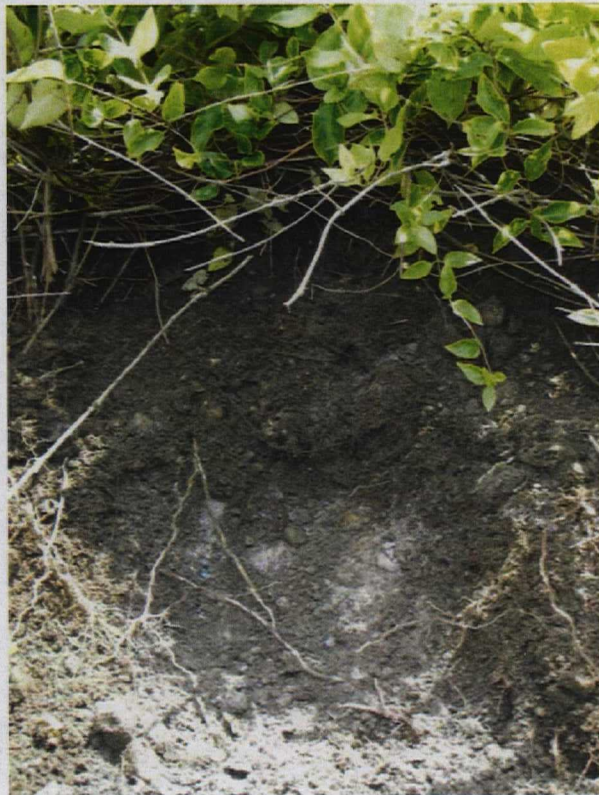
August, 2008

Another view of excavation of saltcake in waste pile at western edge. Vegetation is growing on organic matter that is decomposing on the waste pile, no roots enter the saltcake.

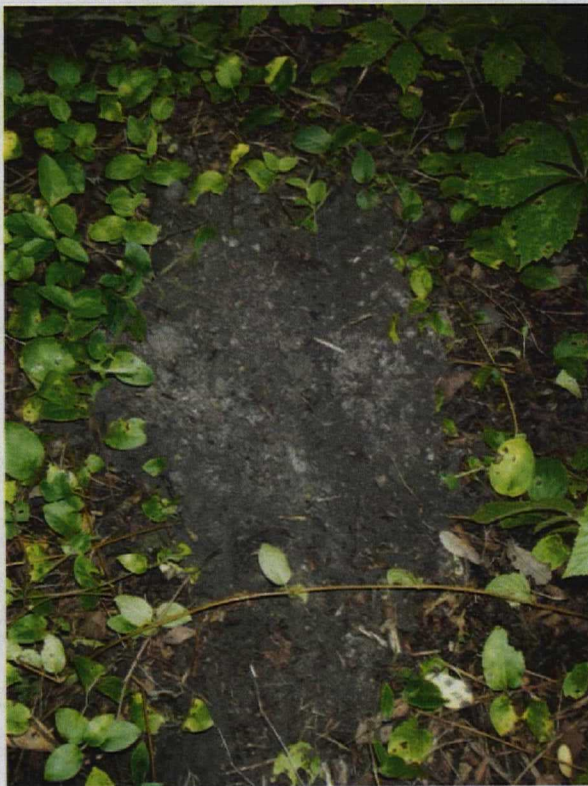
August, 2008

Excavation of saltcake in waste pile at northern edge. As seen on western edge, vegetation is growing on organic matter and no roots enter the saltcake.

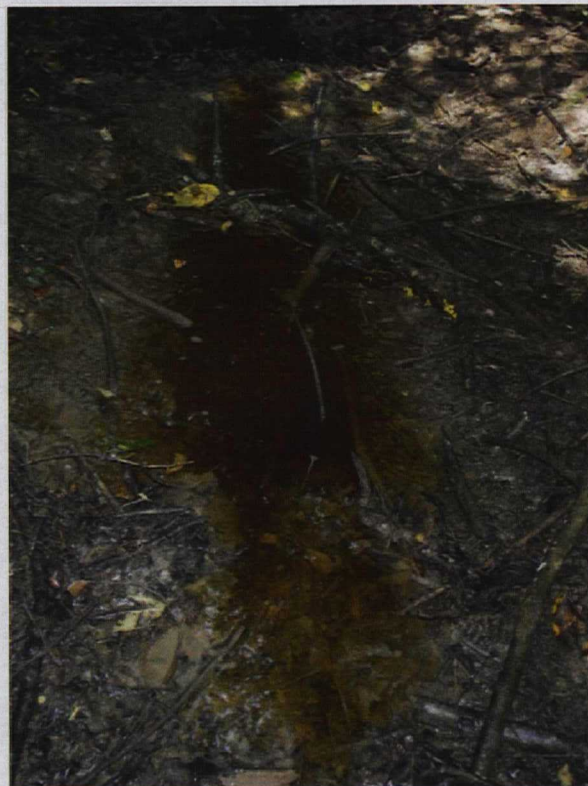
August, 2008

Leachate from the waste pile at western runoff point (low rain volume).

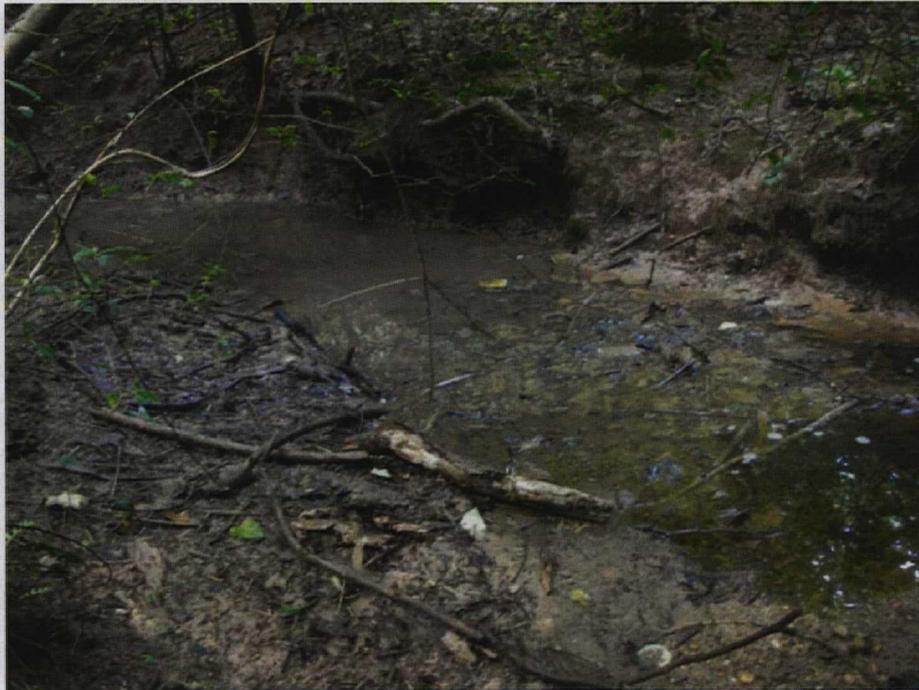
August, 2008

Impact point of leachate at intersection with intermittent stream (grey water at left) with contaminated water (brown water at right) flowing to Flenniken Branch (low rain volume).

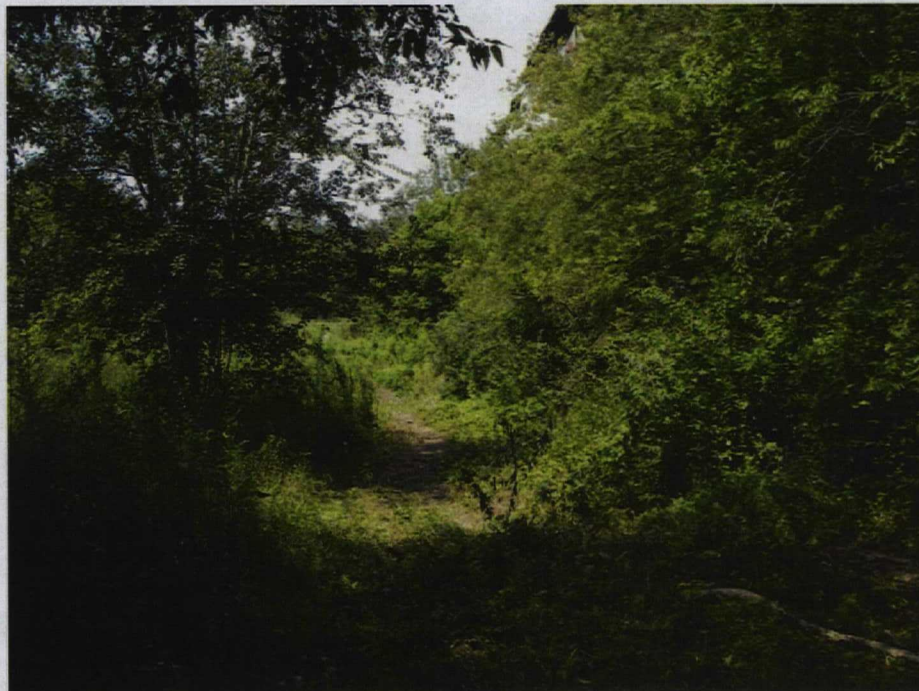
August, 2008

Worn path from trespassers entering from fence breach.

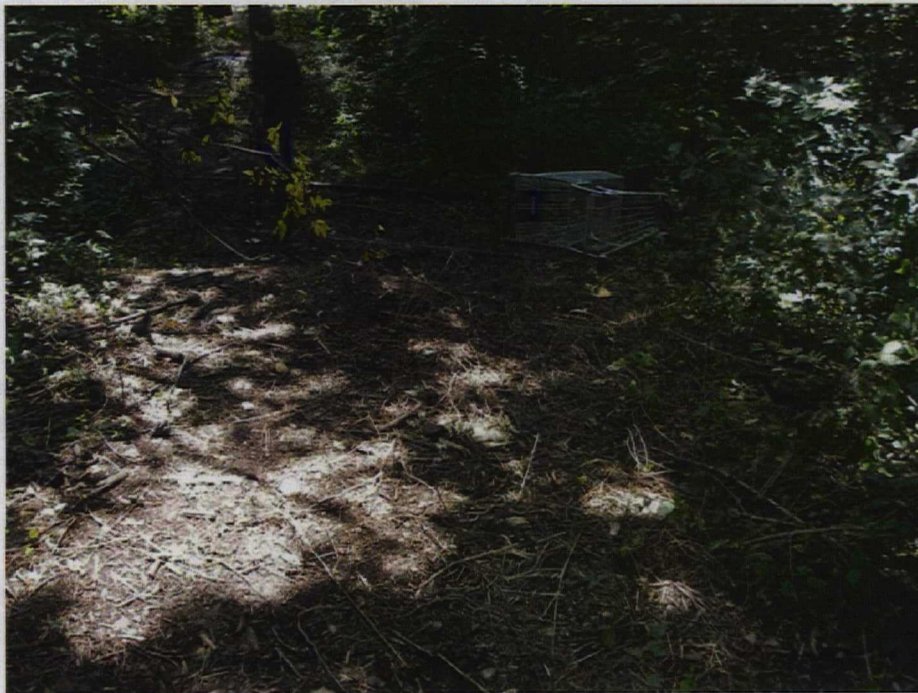
August, 2008

Worn path from trespassers entering from fence breach; shopping cart brought to Site seen in upper right of photo.

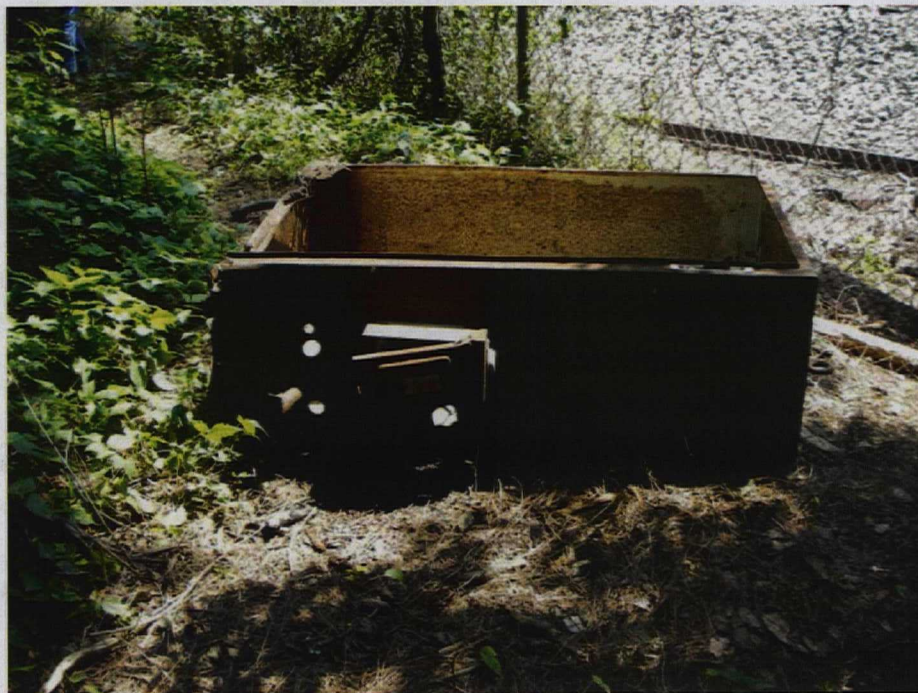
August, 2008

Transformer box dragged from main process building to fence breach. Copper wiring and other devices removed; may have contained lead, mercury, and/or PCB oils.

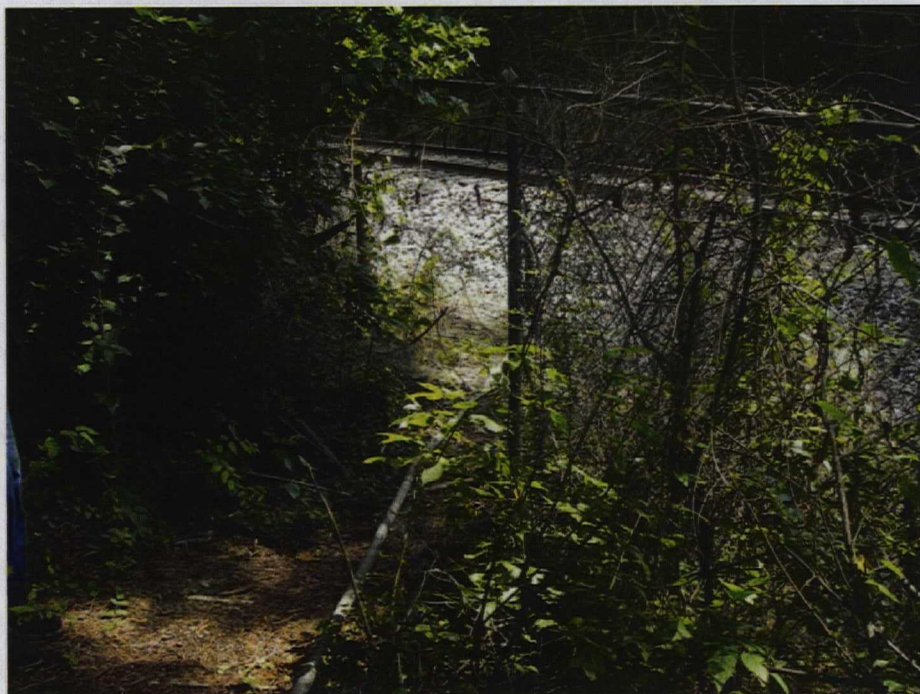
August, 2008

Fence breach as seen from Site, facing south. Apartment complex located adjacent to the Site beginning on the south side of railroad line shown behind fence.

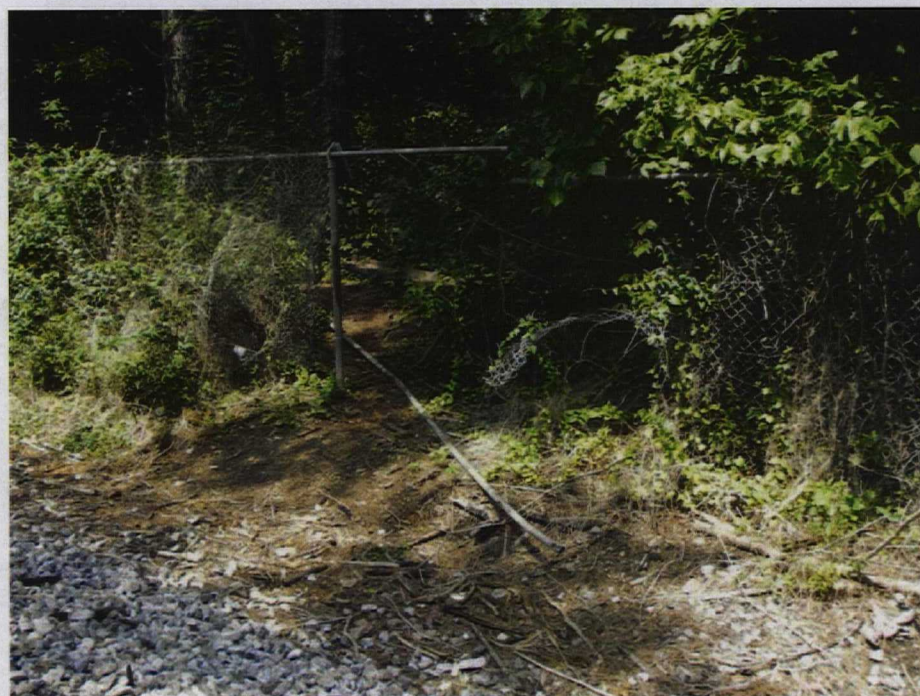
August, 2008

Fence breach as seen from railroad line, facing north. Apartment complex located adjacent to the Site beginning on the south side of railroad line.

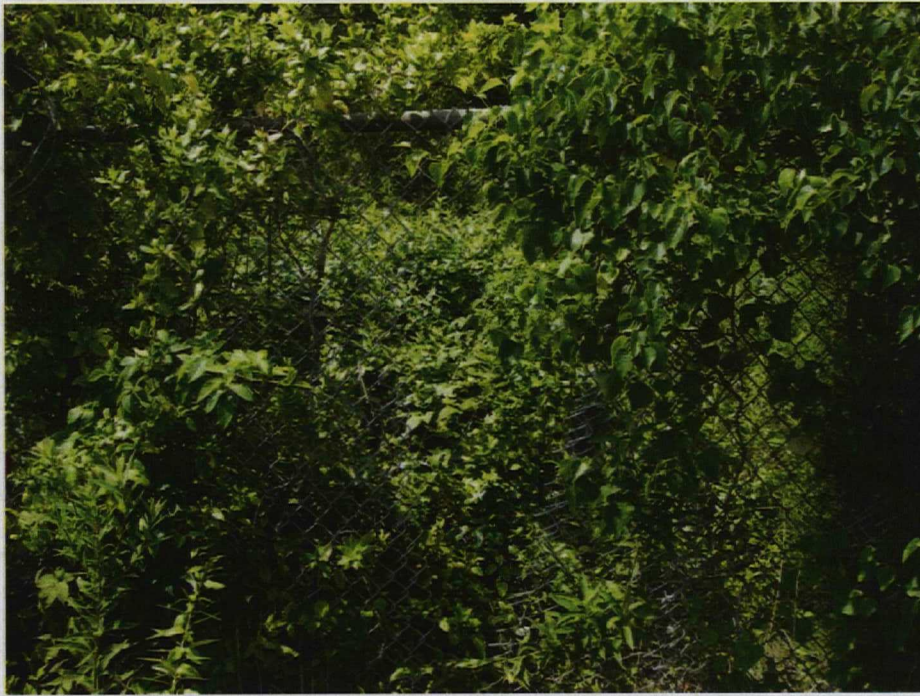
August, 2008
Second fence breach along eastern side.
